BGA 测试座损坏的分析报告

Classification	Complaint =>Customer: Dejitong	
Description	Contacts were chipping after 2000-3000 cycle tests. (Poor durability)

Rejected Q'ty	3 / 100 =>Incidence: 3.0%	
Detected on	NOV 2007	
Product	CSP Socket	777A1056H102C
LOT No.	07042401 =>Shipped on: MAY08, 2007

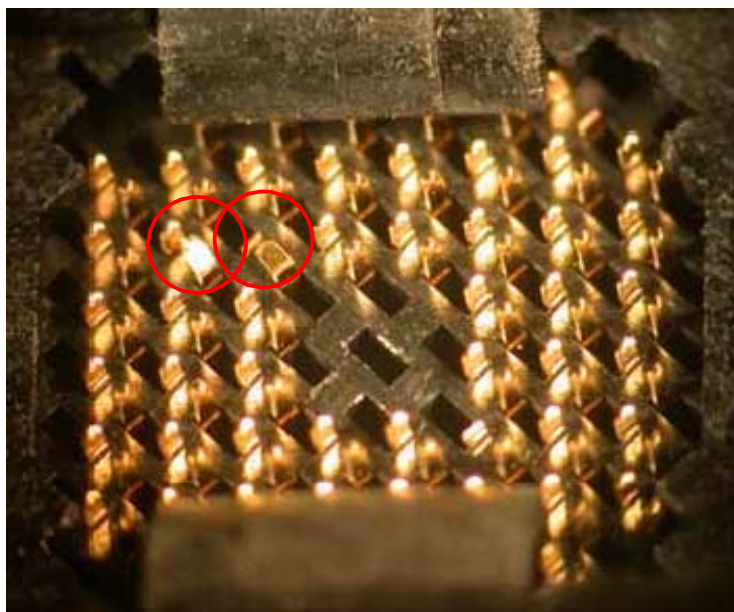
< Return 1 >

Findings We found that some contacts were broken at the top.

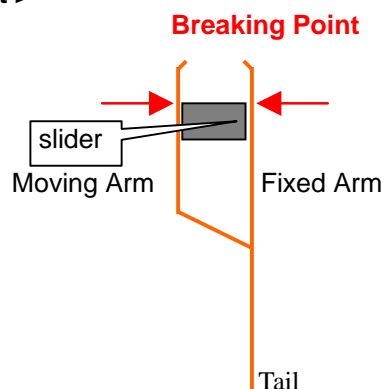
< Pinch Contact >

* Breaking Points were almost same height
with the top of slider.

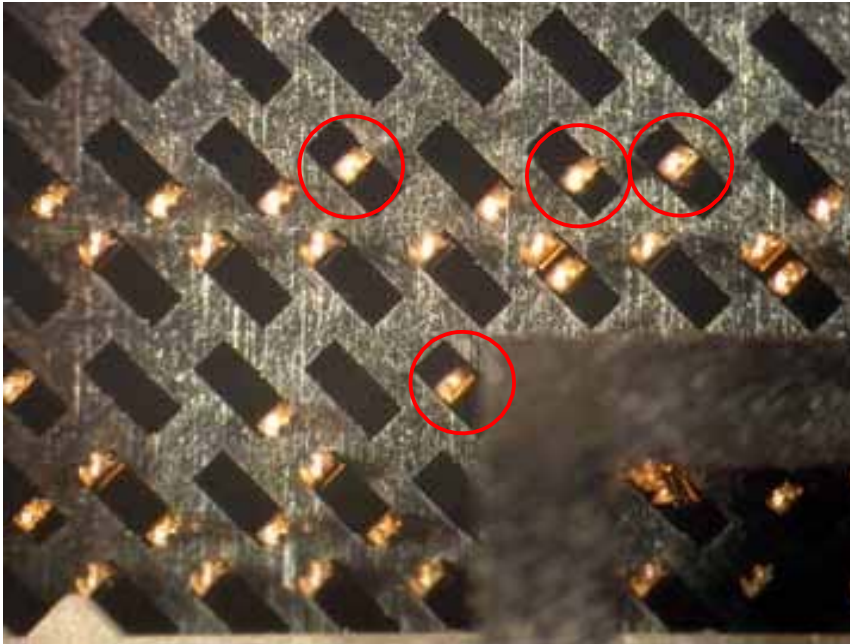
< Reference >

CSP sockets are guaranteed 10,000 time actuations typically. Over 10,000 time actuations, some contacts may show the metal fatigue and break as below.

* We can find the gap between contact and slider.

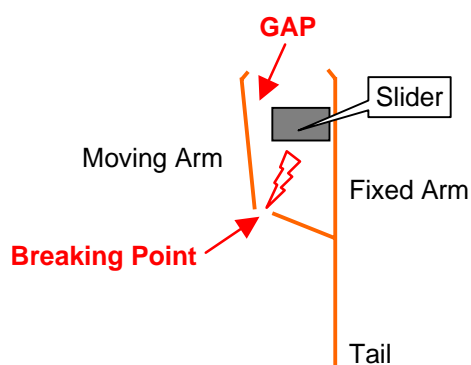
* The metal fatigue shall arise not on the fixed arm but the moving arm.

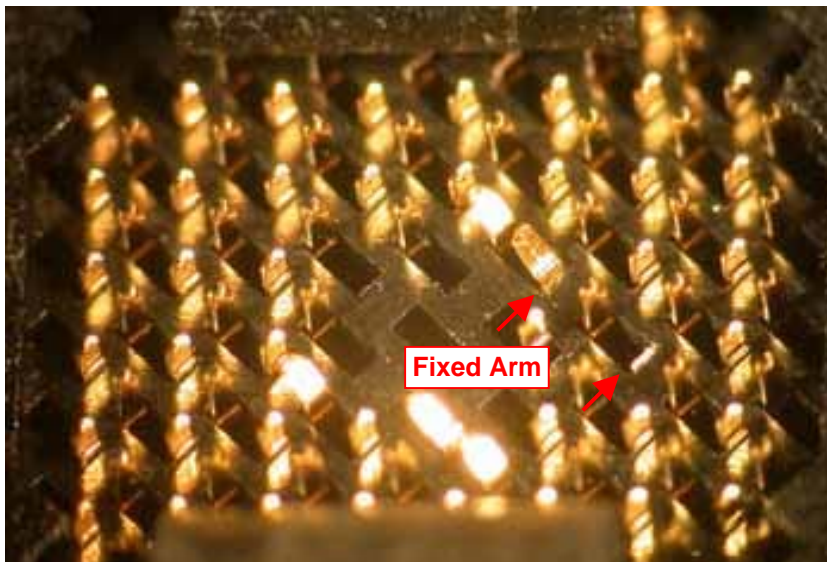
< Return 2 >

We found that some fixed arms were broken on the returned socket.

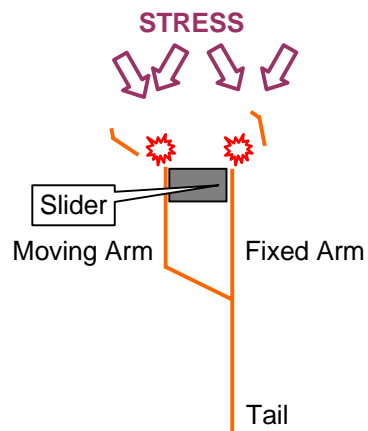
Some kinds of physical stress or damage should hit on the top of contact.

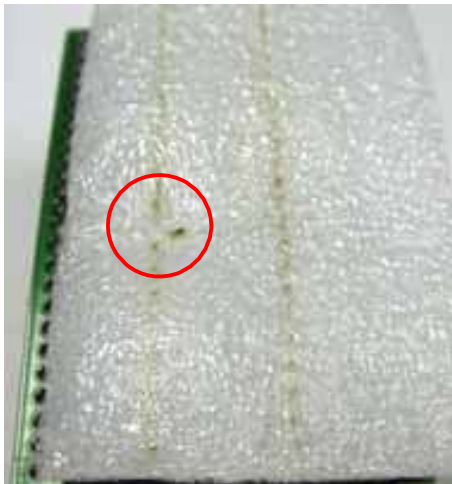
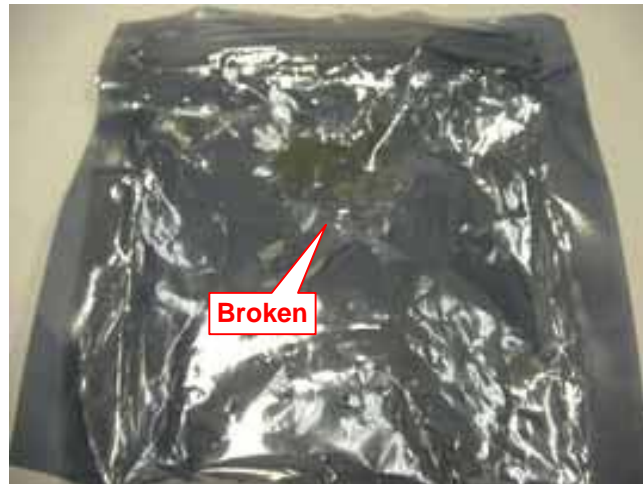
One tail pin of PCB was already bent on the arrival which please note.
